Manhole Inspection Summary

Manhole # **S37S__044MH**

Record Plat: **37S** Node: **044** Status: **Is Storm Sewer Feature** Insp Date: **1/24/08 4:39 PM**

Location Address: **1401 william st**

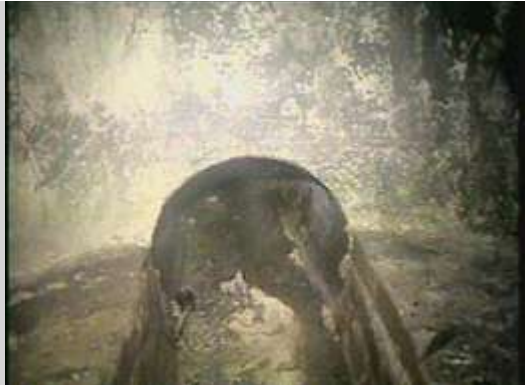
12 O'Clock Outflow

12 in. Circular Gravity Sewer
Pipe Out @ 12 O'Clock

Deposits: ☐ None ☐ Mud ☒ Gravy ☐ Debris ☐ Grease

Silt Depth: 2 (in.) Deposits Extent: Medium

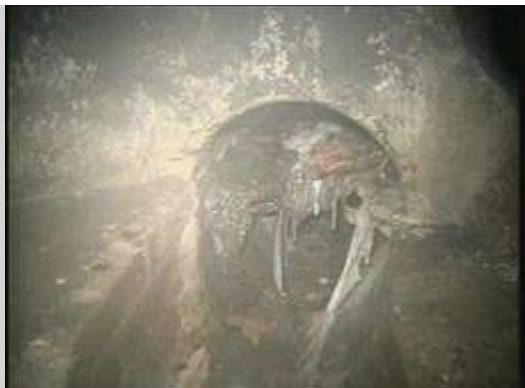
7 O'Clock Inflow

12 in. Circular Gravity Sewer
Pipe In @ 7 O'Clock

Deposits: ☐ None ☒ Mud ☒ Gravy ☒ Debris ☐ Grease

Silt Depth: 6 (in.) Deposits Extent: Heavy
